THAMES RIVER BASIN
NORWICH, CONNECTICUT

TAFTVILLE RESERVOIR NO. 2 DAM
CT. 00201

PHASE I INSPECTION REPORT
NATIONAL DAM INSPECTION PROGRAM

JANUARY 1979

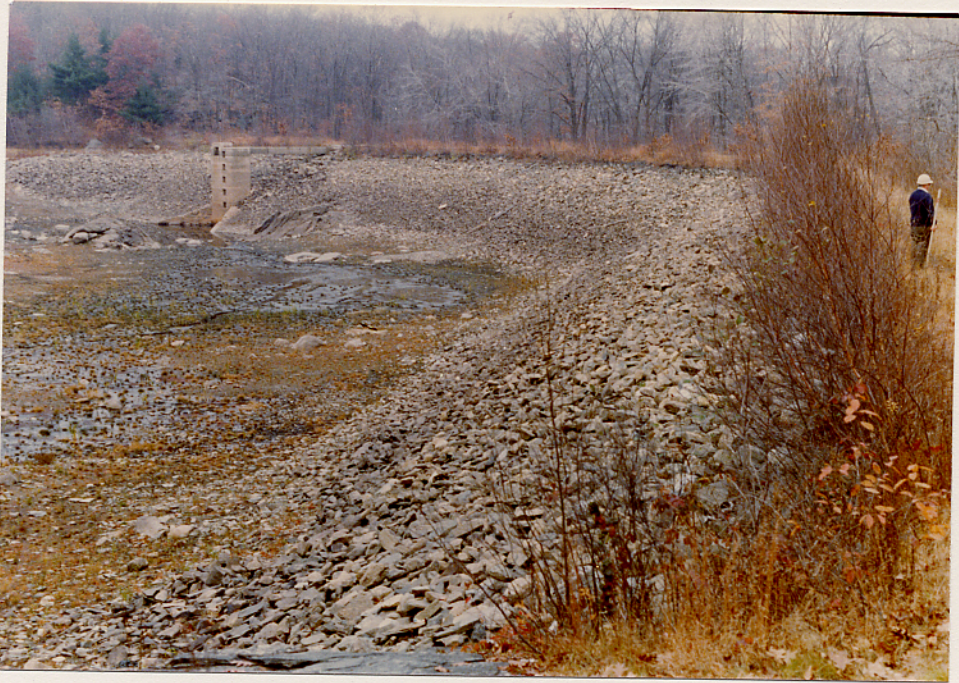
Overview from right abutment.

The dam is constructed on a north-south arching alignment between two anchoring rock outcrops at the abutments. The upstream and downstream rockfill slopes are in generally good condition (Overview Photo). Brush growth on the crest and slopes is beginning to take serious hold and some down-slope displacement of the downstream face, consisting of rather small stone, is locally evident. Opposite the inlet structure, the downstream slope displays severe erosion and sloughing. A well-worn footpath or motorcycle trail exists along the crest.

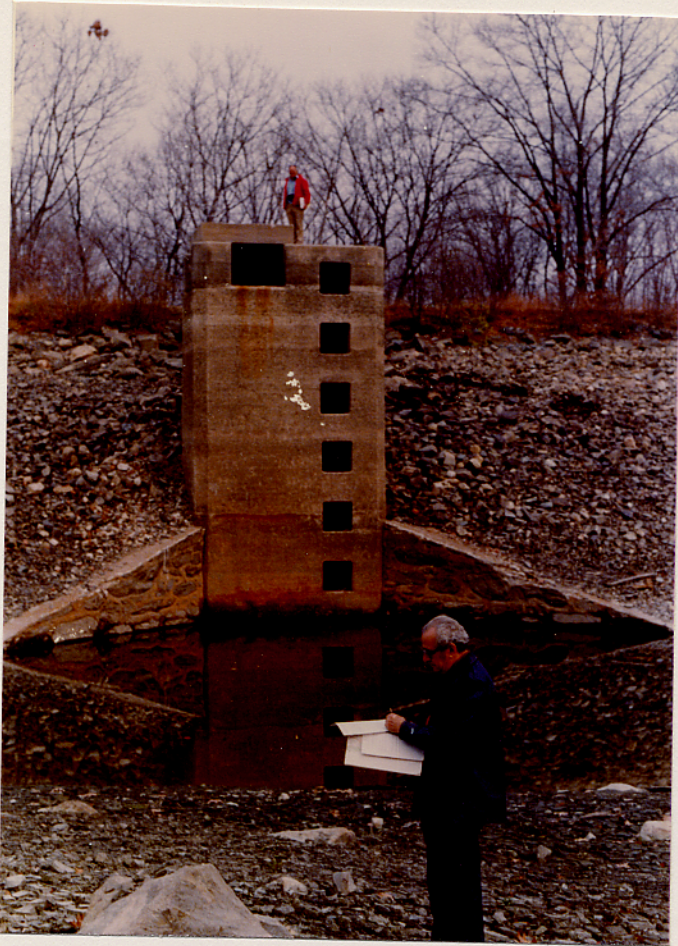
The outside of the drop inlet spillway and outlet works intake tower was visible in its entirety owing to the reservoir being empty (Appendix C, Photo No. 1). The concrete appeared to be in good condition. The tower house built of concrete block has been dismantled by vandals, and the material has been hauled away. The floor plate covering the tower wells cannot be removed because vandals have beaten the nuts holding the plate so that they cannot be loosened. Some of the vertical trash bars at the drop inlet spillway crests are missing. The copper mesh screens at the back of the inlet ports of the outlet structure well have fallen off and can be seen through the ports lying at the bottom of the tower well. With the removal of the tower house, there are

1. Tower with drop inlet spillway and outlet works intake.

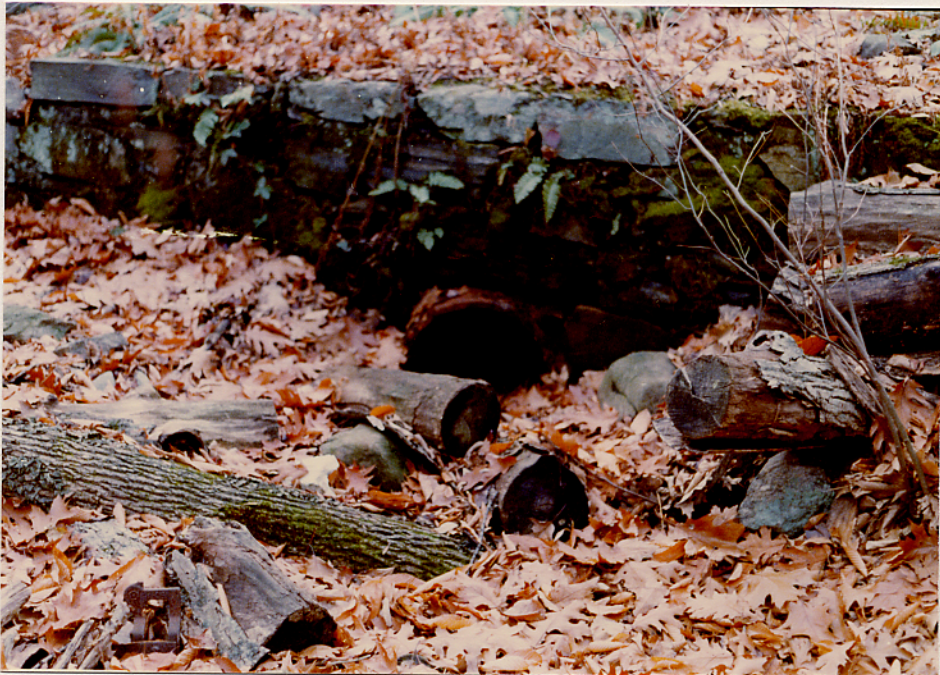
A seepage condition was noted in previous reports at the downstream toe of the dam near the exit point of the 16-in. dia. spillway outfall pipe (Appendix B). With the reservoir empty at the time of the inspection, this seep was not in evidence.

2. 16 in. dia. spillway outfall pipe.

1. Remove all brush and saplings from crest, auxiliary spillway, and downstream slope of embankment, and keep future growth cut on a regular basis.
2. Replace displaced riprap/rockfill on both upstream and downstream slopes.
3. Monitor the downstream toe of the dam for possible seepage periodically during periods of high reservoir level and not less than once each year. Particular attention should be given to the area around the exit point of the 16 in. dia. spillway outfall pipe, where seepage was recorded on previous inspections.

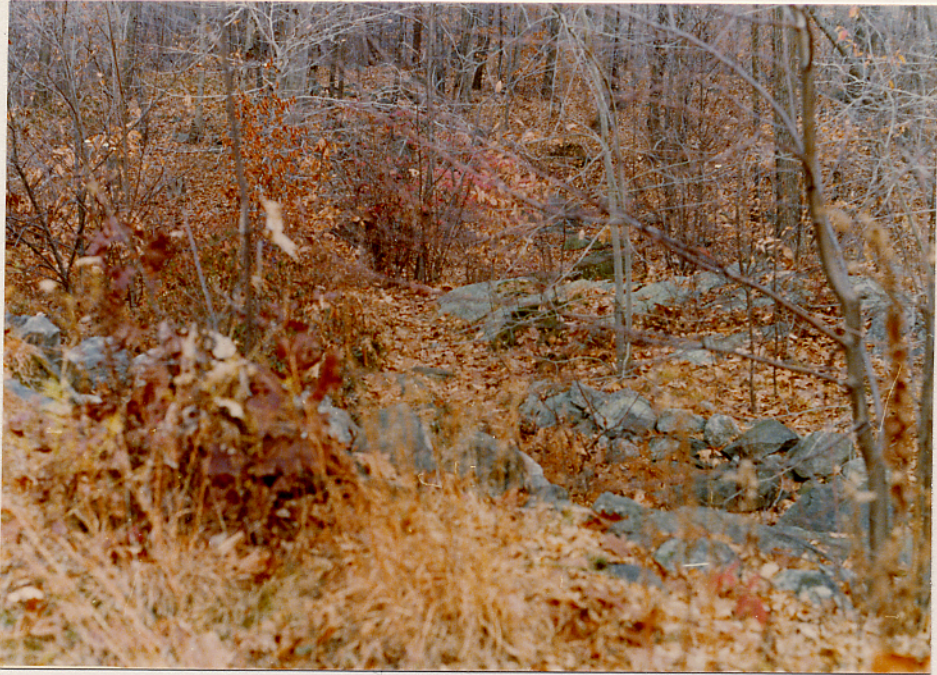
3. Auxiliary spillway notch in crest.

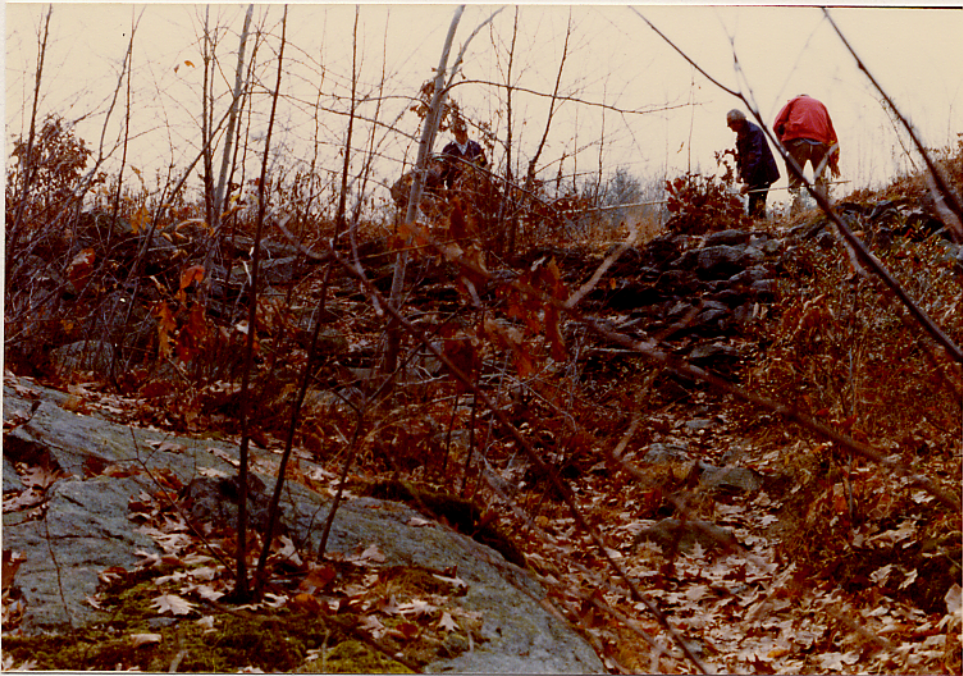
4. Auxiliary spillway notch in crest.
